HO-419

Holly House Farm  
12402 Lime Kiln Road  
Private

## Maryland Inventory of Historic Properties Form

Inventory No. HO-419

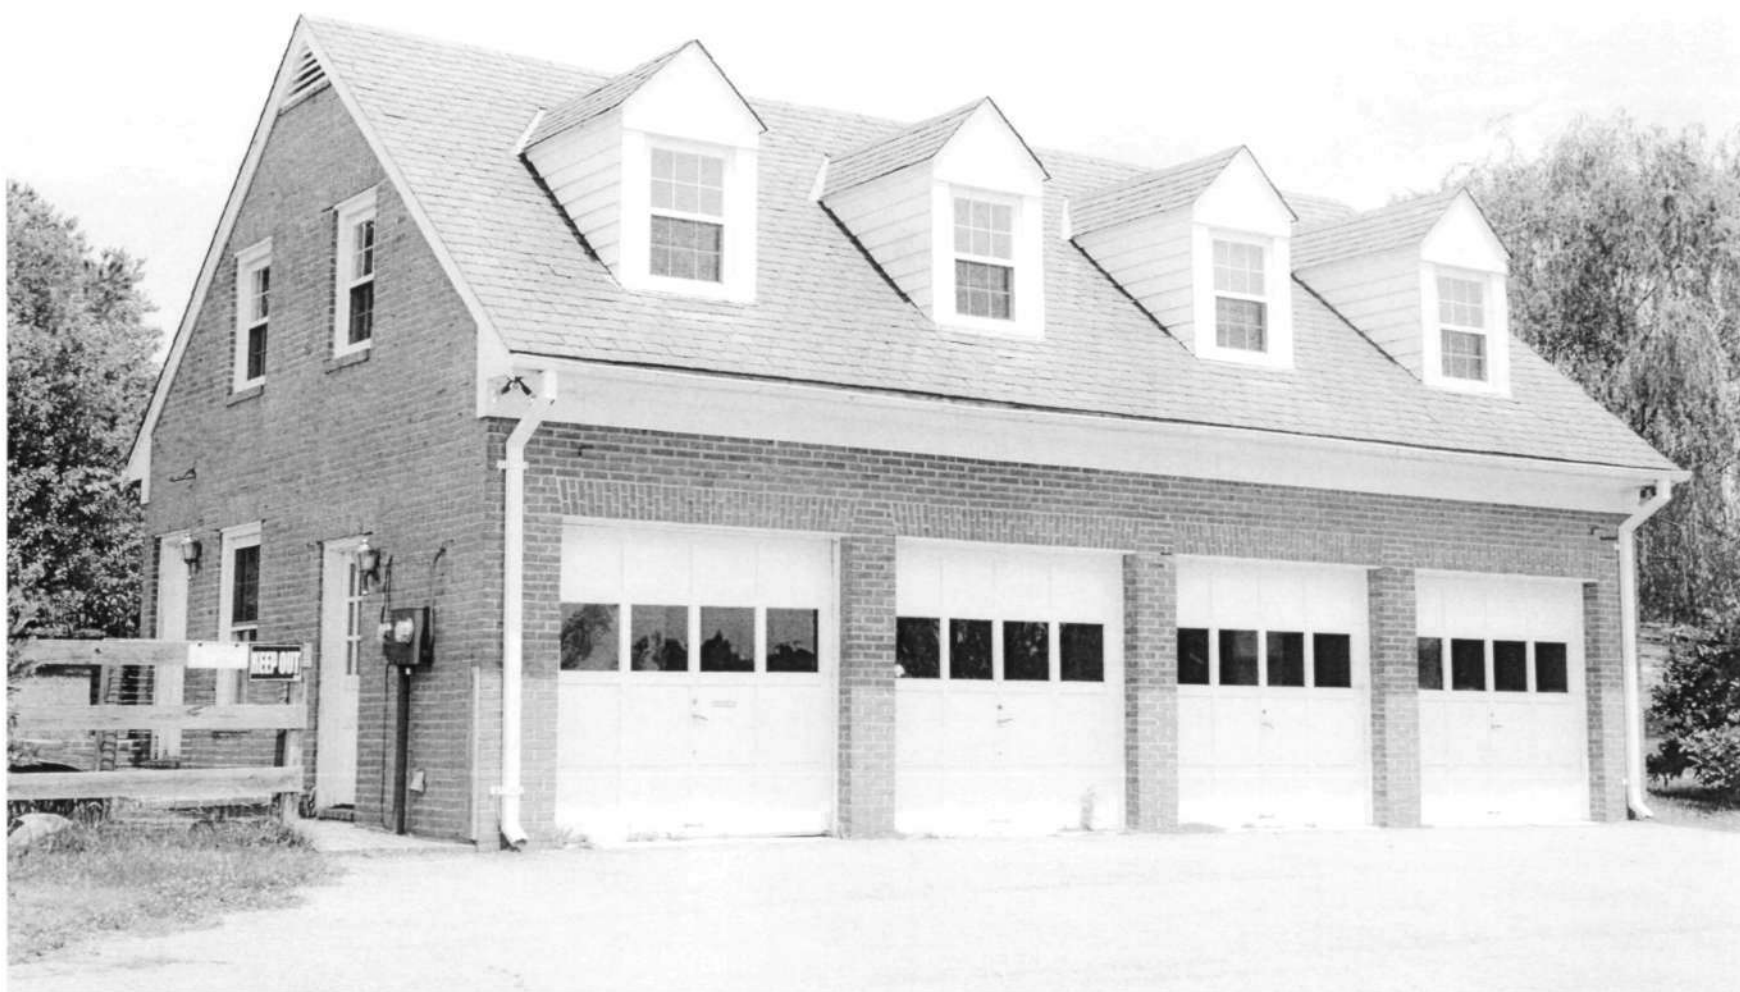
About 50 feet northeast of this brick outbuilding is a brick garage. It is a 1-1/2 story, four-bay by three-bay structure of running bond brick that seems to be of the same era as the house. The garage has a gable roof with slate, and has an east-west ridge. The south elevation has four roll-up doors with gabled dormers above that contain new six-over-six sash with fake muntins. The west elevation has a flush door to the north, a new six-over-six sash in the center, and a door to the south that has nine lights over three panels. There are two new six-over-six sash in the gable end. The north elevation has no openings on the first story, and has a shed dormer that has four new six-over-six sash. The east elevation has two new six-over-six sash on both the first story and the gable end.

HO-419 Holly House Farm 12402 Lime Kiln Road Brick garage, west & south elevations  
Ken Short, June 2006 12/18

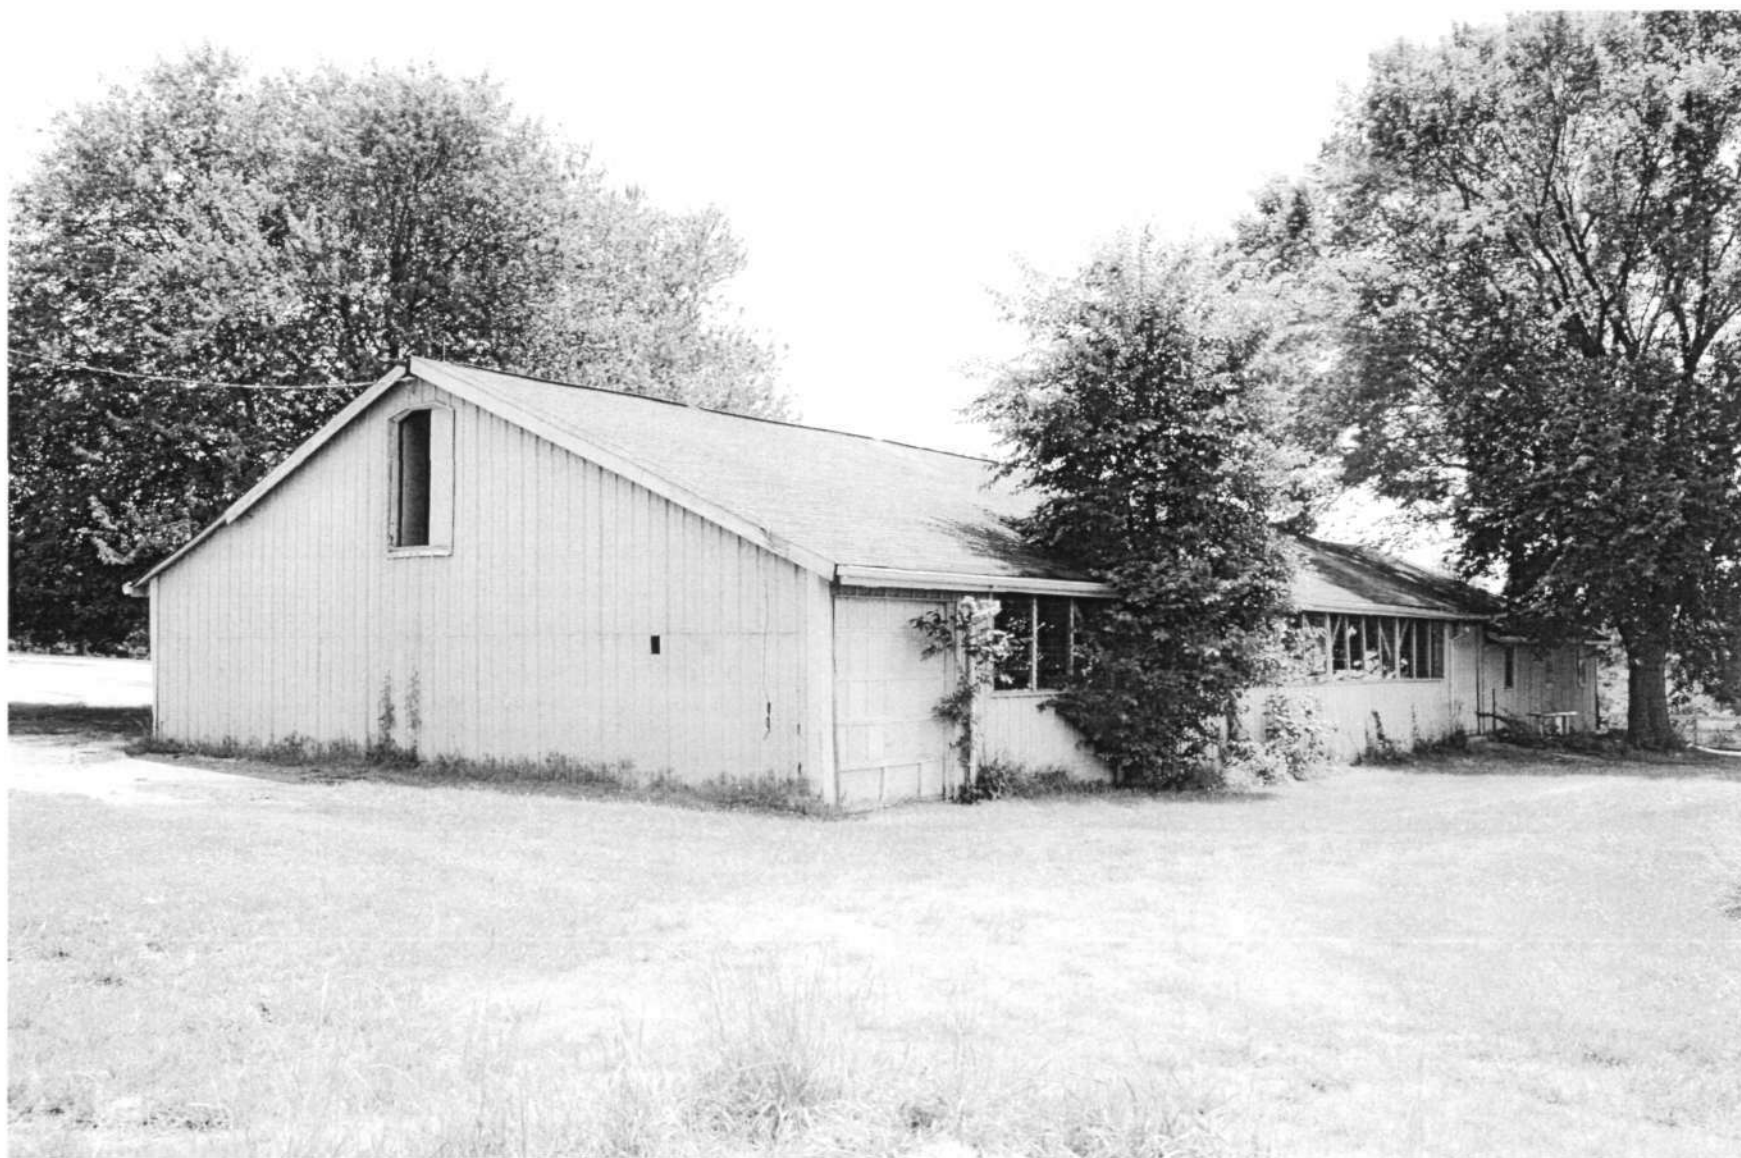
There is a large barn located about 50 feet north of the brick garage. It is a 1-1/2 story structure with T1-11 siding and a gable roof with asphalt shingles and a north-south ridge. It has jalousie windows, which enclose an earlier, smaller stable that has circular-sawn board and batten siding. The stable has 10 pens, five on the east and five on the west, and each pen has doors on rollers. There are also iron bars on window openings to each pen, and the pens have vertical board partition walls. The building is constructed with 4x4 posts and plates, nominal 2 by 6 circular-sawn joists and 2 by 6 rafters that are mitered and butted at the ridge. It is constructed with wire nails. The south end of the large barn has a CMU foundation, T1-11 siding, and a gable roof with asphalt shingles. This section must have been added, and is not historic.

HO-419 Holly House Farm 12402 Lime Kiln Road Large barn, north & west elevations  
Ken Short, June 2006 13/18

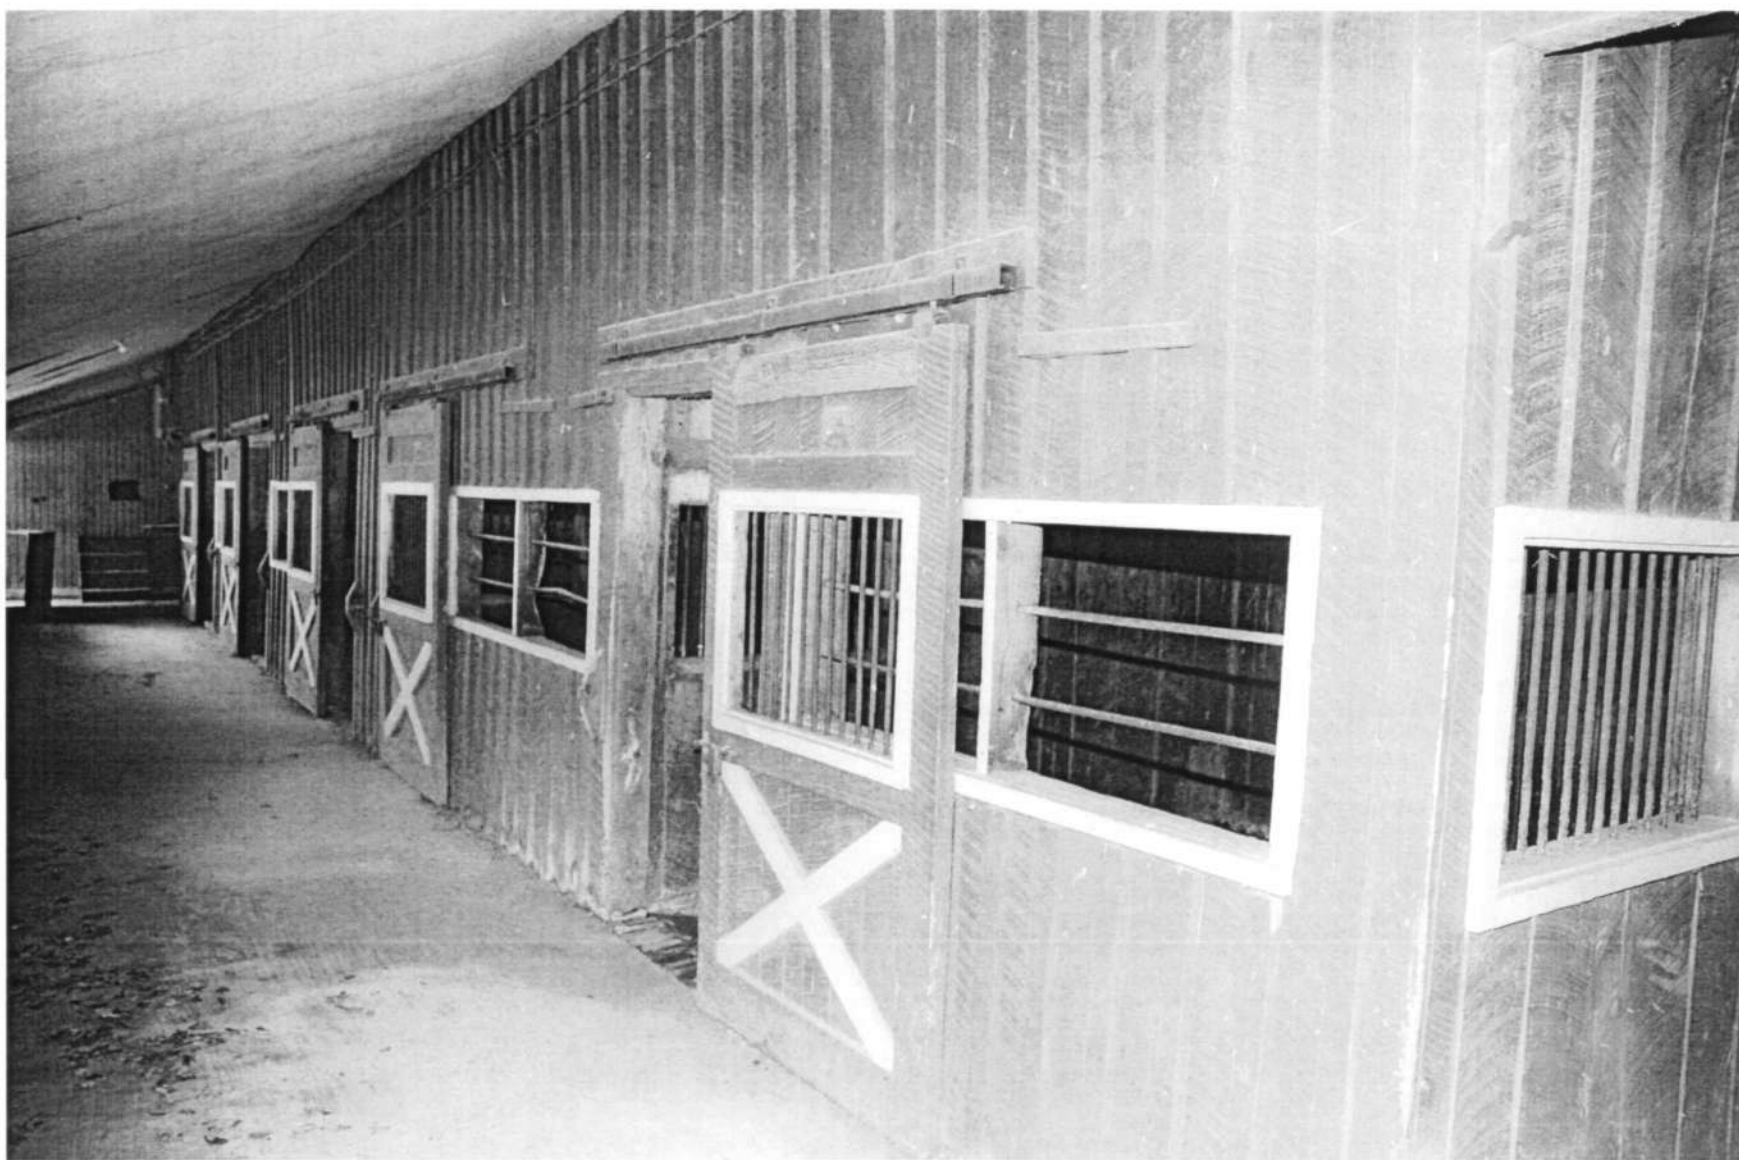
HO-419 Holly House Farm 12402 Lime Kiln Road Large barn, interior, east side, vw. south  
Ken Short, June 2006 14/18

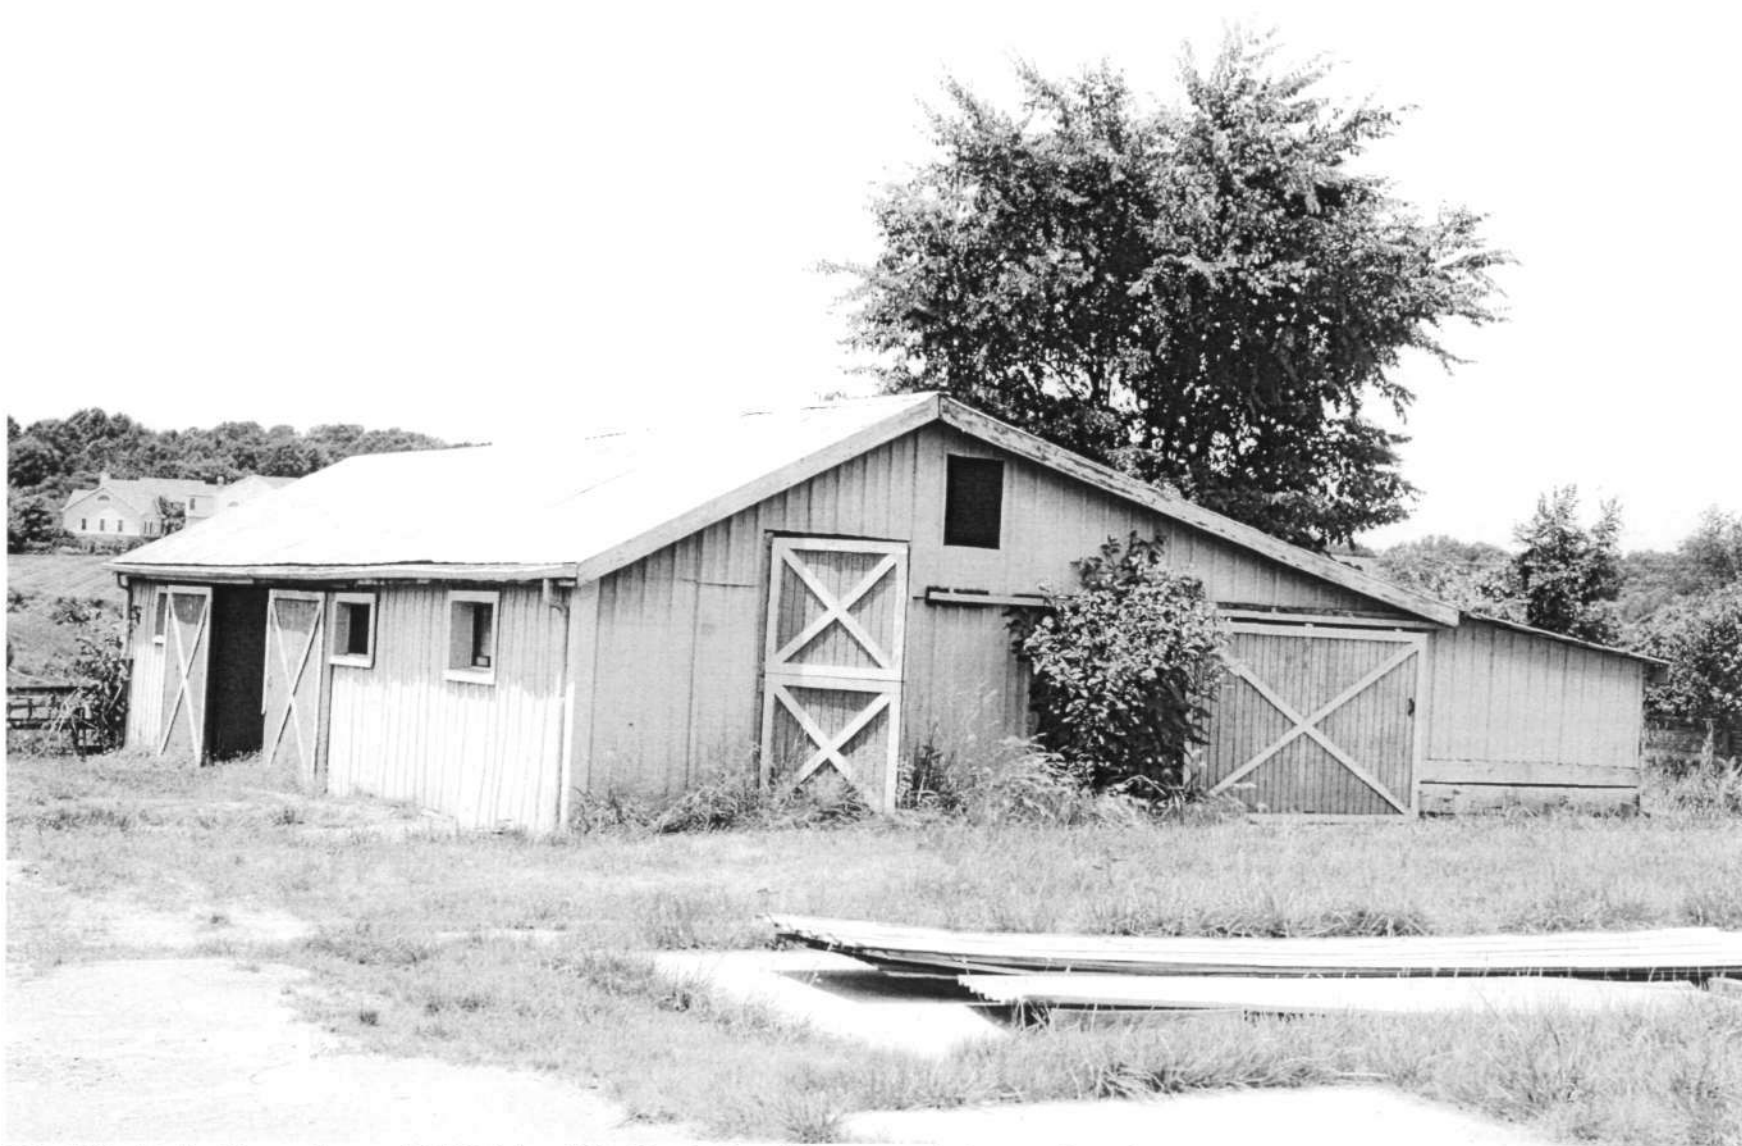
HO-419 Holly House Farm 12402 Lime Kiln Road Small barn, south & east elevations  
Ken Short, June 2006 15/18

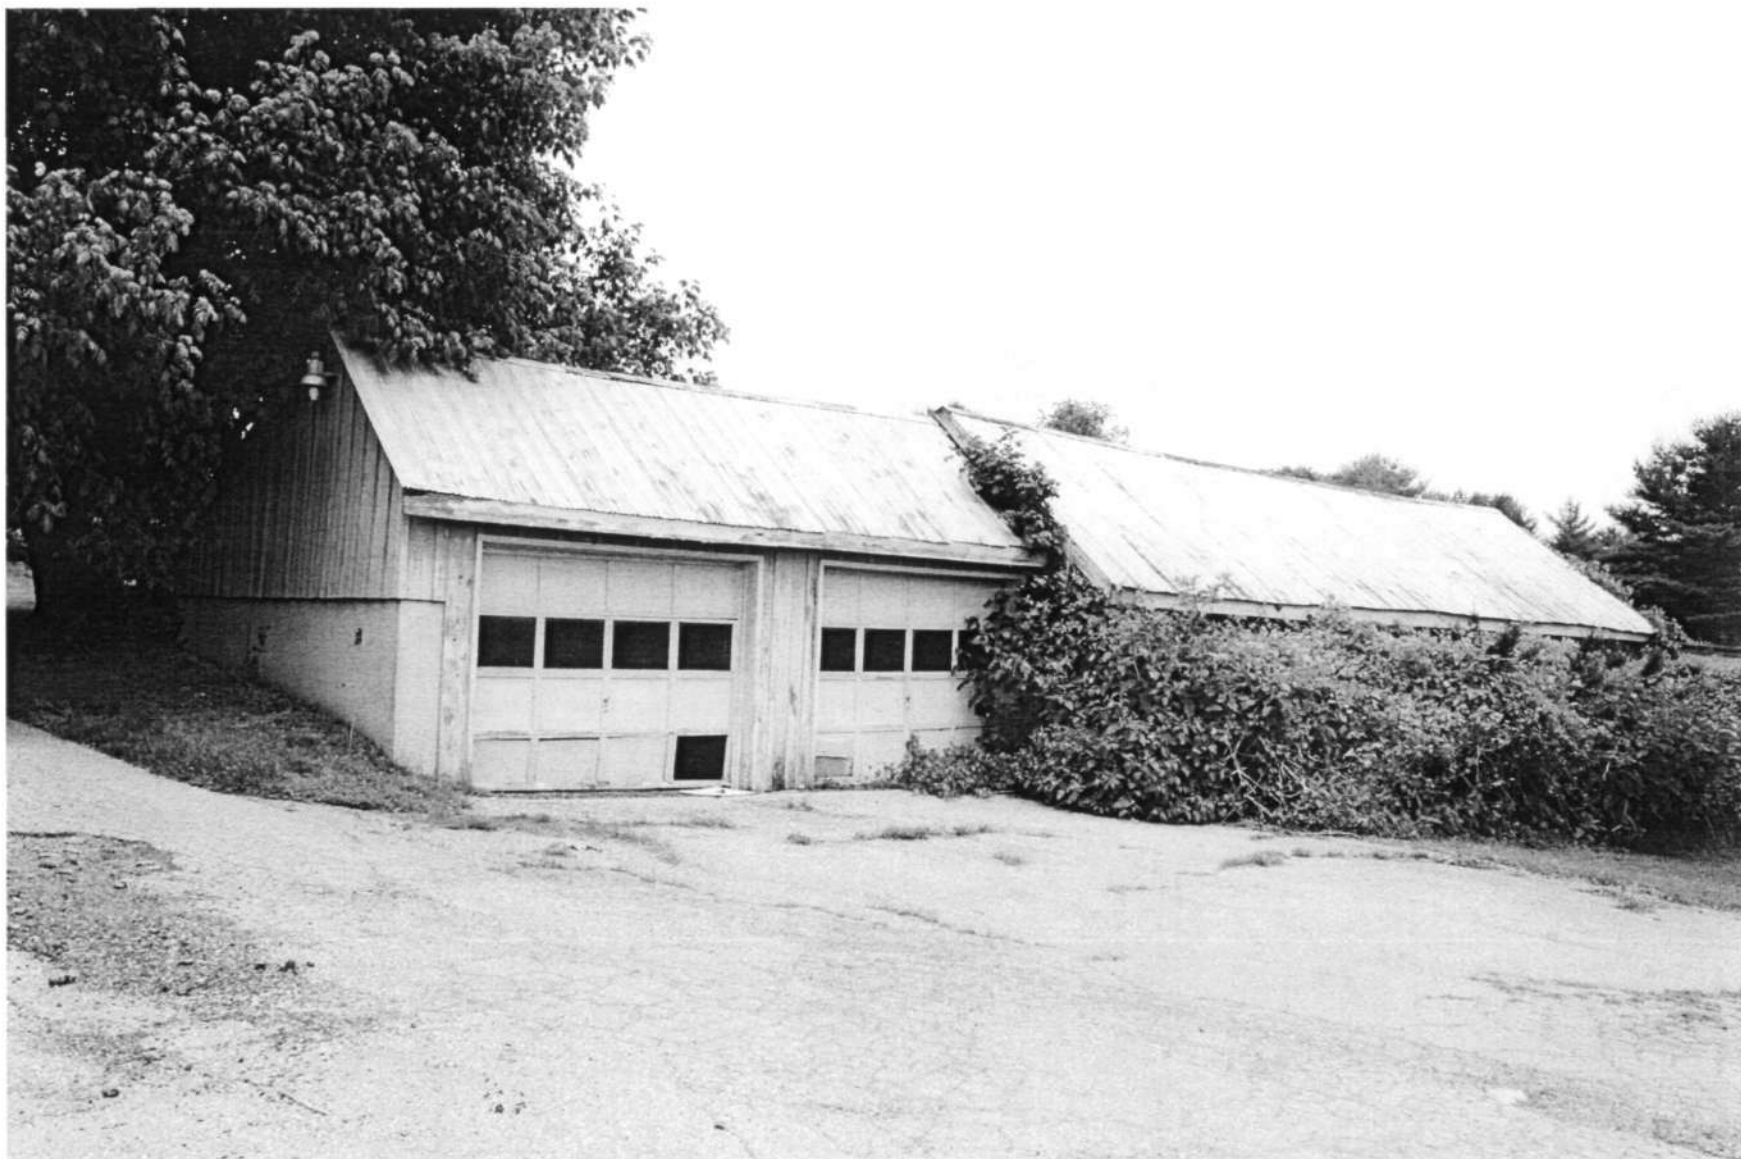
There is a new garage located about 60 feet southeast of the brick garage. It has a concrete foundation, circular-sawn board and batten siding, and a gable roof with an offset ridge and double inverted-V-seam metal roofing. This building is not historic.

HO-419 Holly House Farm 12402 Lime Kiln Road New garage, west & south elevations  
Ken Short, June 2006 16/18

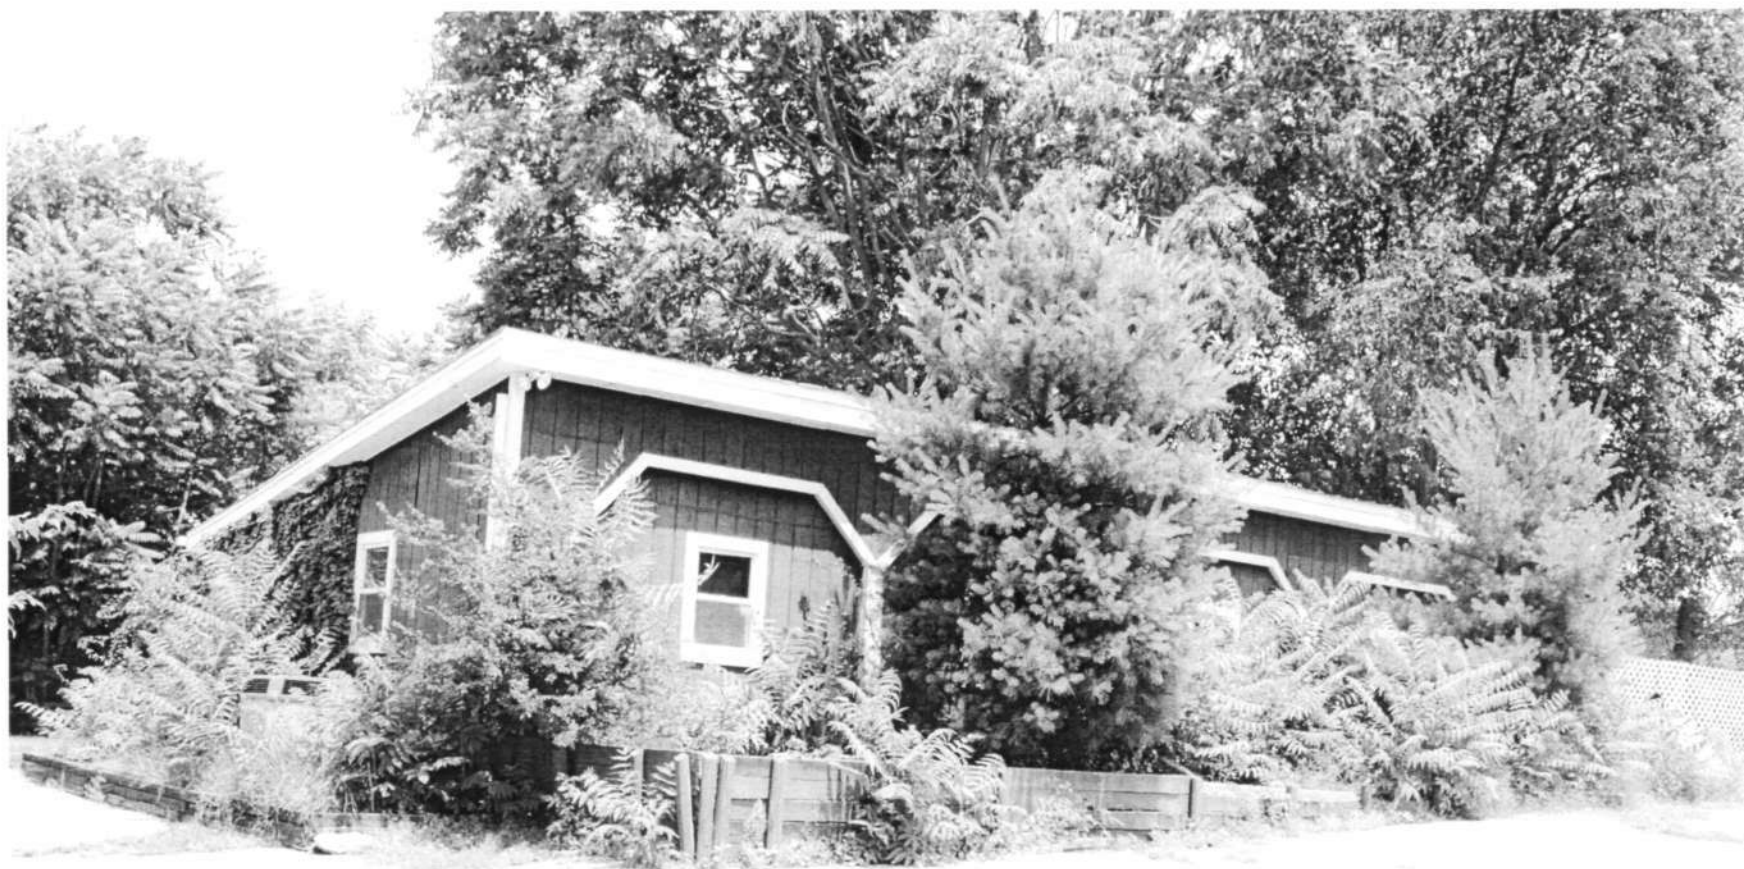
To the west of the tenant house is a recording studio. It is a one-story, four-bay by two-bay frame structure with concrete foundation and T1-11 siding. The shed roof has inverted-V-seam metal, and this could be a converted tractor shed. The building was not accessible, and is not historic.

HO-419 Holly House Farm 12402 Lime Kiln Road Recording studio, west & south elevations  
Ken Short, June 2006 17/18

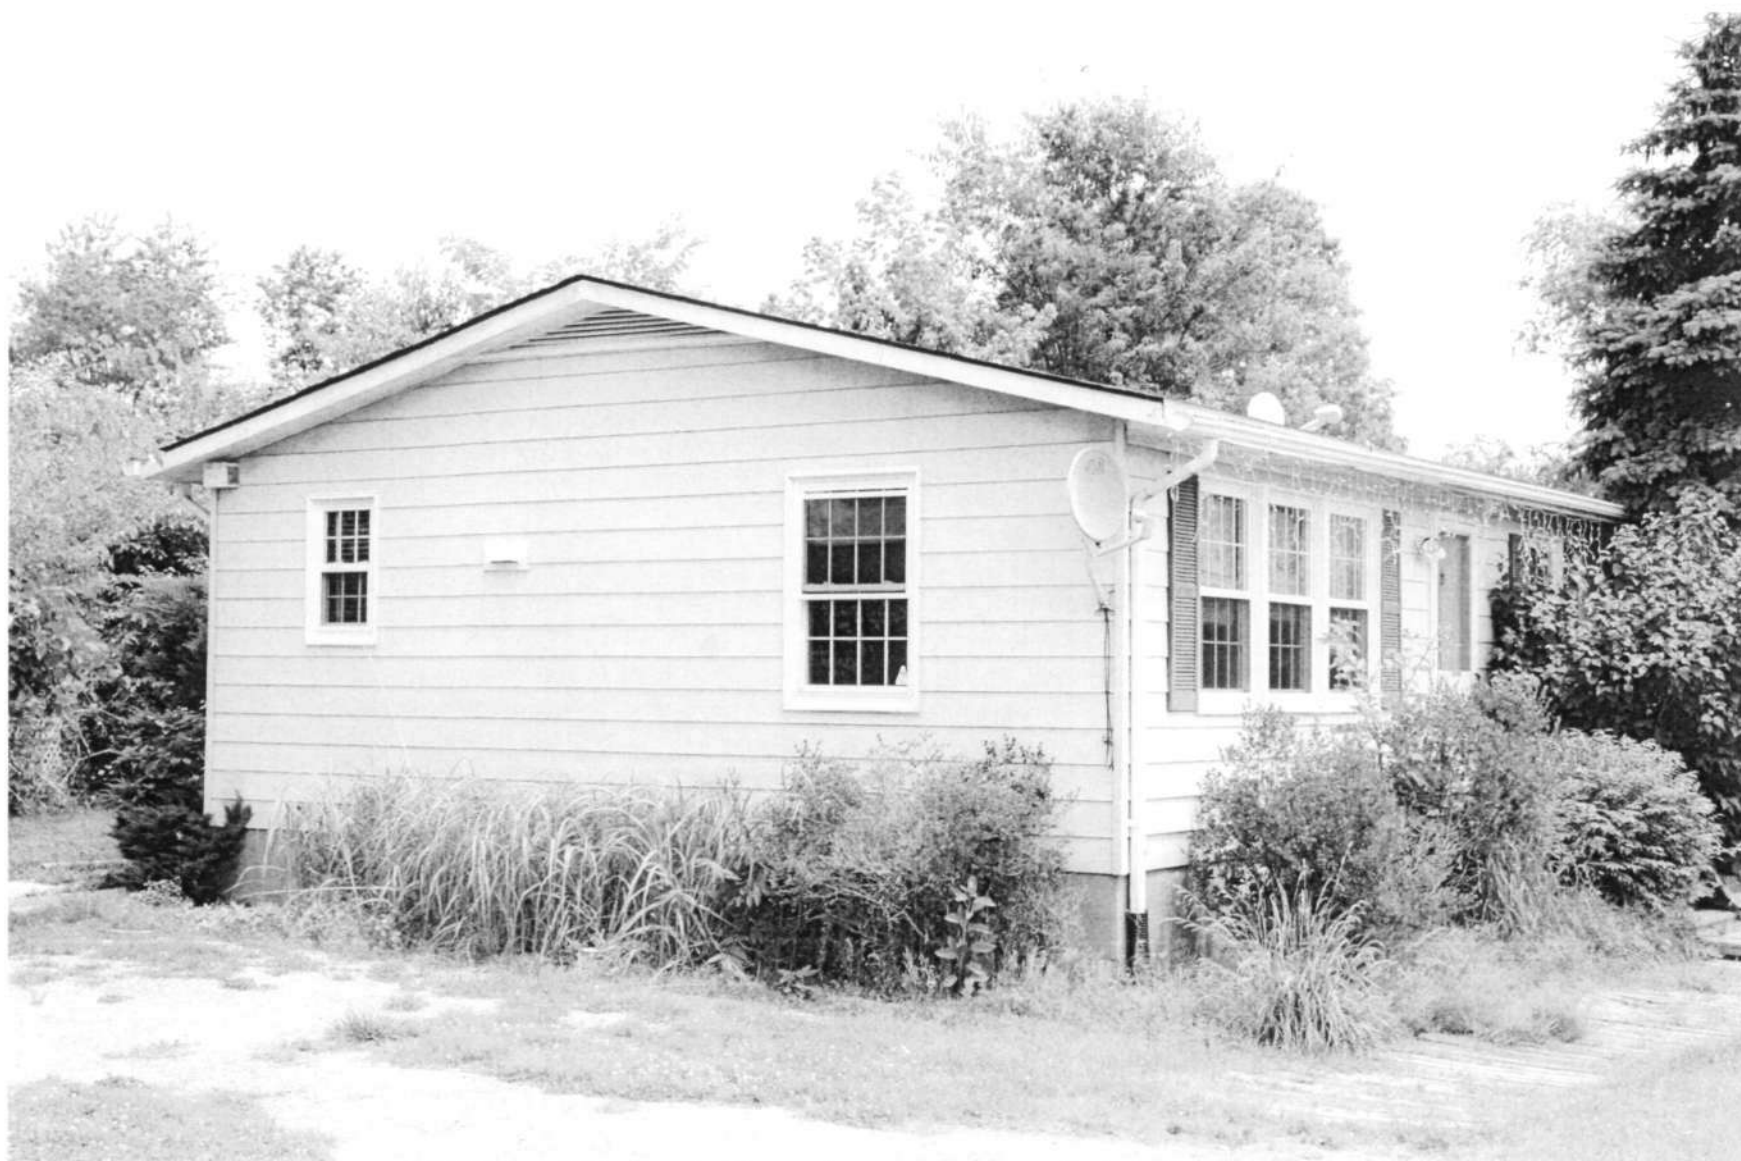
There is also a tenant house on the property. It is a one-story, four-bay by two-bay frame structure on a parged foundation. It has aluminum siding, a shallow gable roof with asphalt shingles, and new sash with fake muntins. This building is also not historic.

HO-419 Holly House Farm 12402 Lime Kiln Road Tenant house, west & south elevations  
Ken Short, June 2006 18/18
